HARDWARE ERRATA REPORT

P/N **PBA-B-01**

phyFLEX Baseboard

Revision A0, 20 January 2014

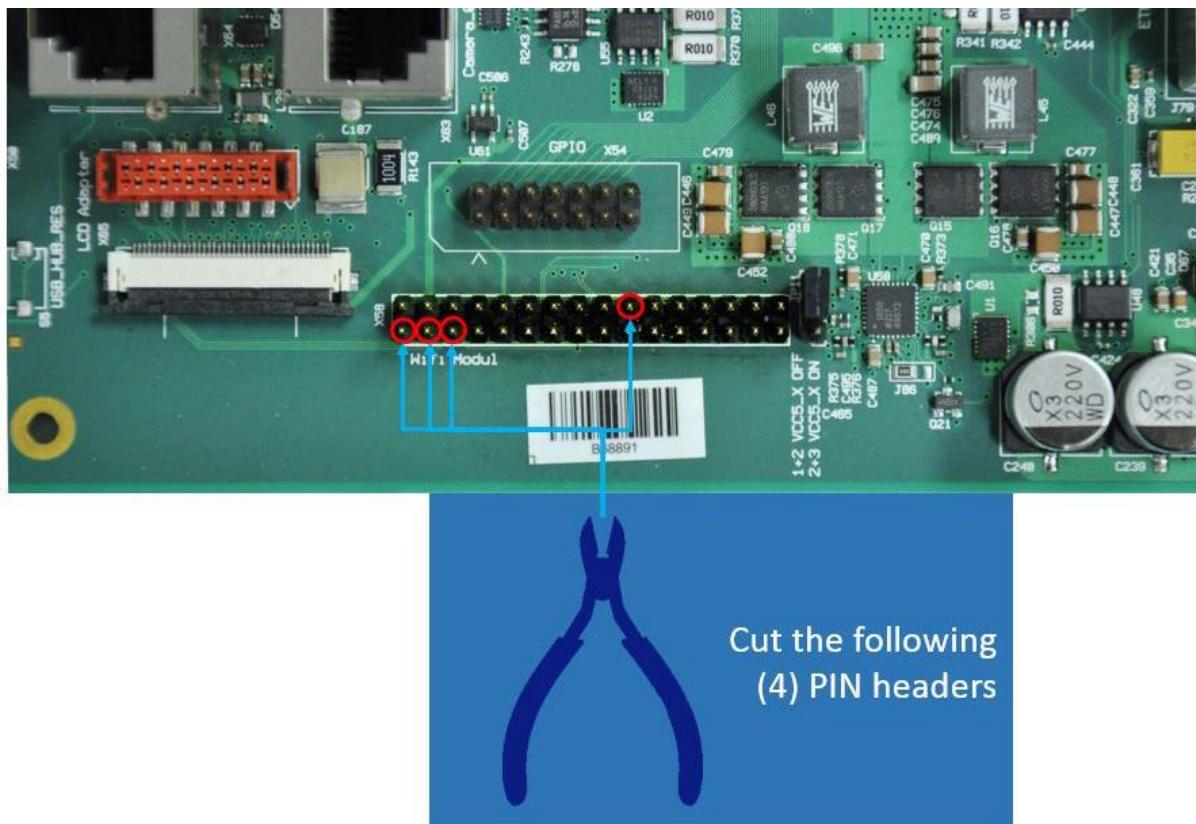
Figure 1: Errata 01 Rework

Errata Impact: The i.MX6 fails to boot from SPI NOR Flash when the WiFi module (PCM-958) is connected.

Errata Description: The Baseboard routes SPI0 signals to the WiFi module connector X58. When the WiFi module (PCM-958) is connected to the Baseboard the SPI0 signal voltage lowers. Since the SPI0 signals are connected to the i.MX6 SOM on-board SPI Flash the board will fail to boot from SPI Flash.

Workaround: Hardware rework is required to disconnect the SPI0 signals from being routed to the WiFi module. On the Baseboard cut the SPI pin headers 1, 3, 5, and 20 at X58. Figure 1 below shows which pins must be cut before inserting the WiFi module.
